# TENNESSEE HOME SAVED FROM DANGEROUS SETTLEMENT

## INSTALLATION OVERVIEW

**Product Used**  
2 7/8" Helical Piles

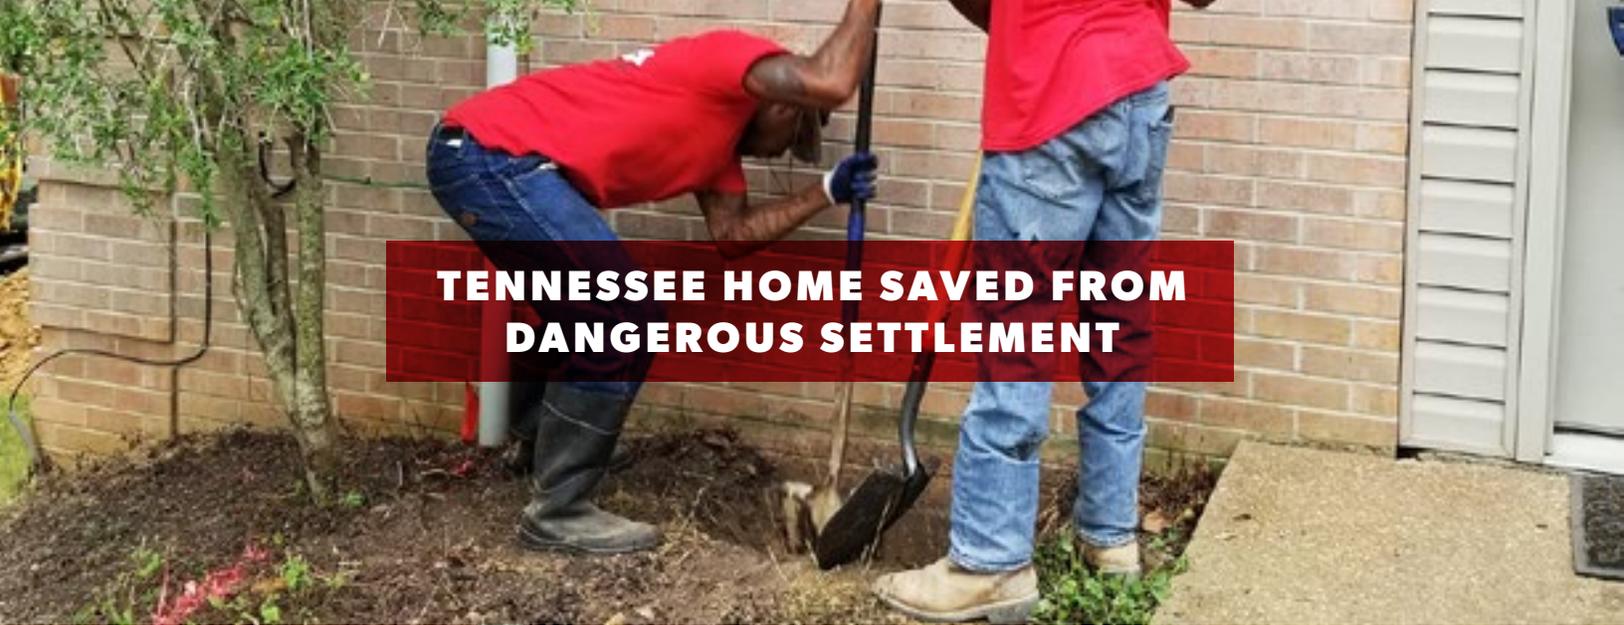
In the city of Milan, Tennessee, home to just under 8,000 residents, a homeowner started noticing cracks appearing in the brick of their home. Luckily, this particular homeowner knew exactly who to call.

Eddie Bolton, the owner of Ram Jack Tennessee, knew that these cracks would continue to expand due to his many years of experience in the foundation solutions industry. He contacted his team of foundation specialists to evaluate the situation. Upon review, it was determined that the root cause for separation in the bricks was settlement caused by the clay soil in which the home was built. The expansion and contraction of this clay soil affected the foundation of the home and produced potentially dangerous settlement. The home has an excellent footer and as a result, it took 25 years for these cracks to appear.

Bolton, knowing the risks of delayed action, got to work devising a plan. As the cracks were found during the early stages, it was determined that only five 2 7/8 in. Ram Jack helical piles would be utilized to lift the section of the home where the settlement was starting.

While this project seemed fairly simple, the exceptionally hard, clay foundation had to be taken into account. After digging through this rough terrain, the helical piles were able to be successfully installed. As action was taken immediately, the home did not need to be raised. The helical piles would be used to hold and prevent further settlement in the affected area of the home. Bolton was very pleased to have his home secured. He can rest assured knowing that Ram Jack products will withstand the lifetime of the home.
